TECHNICAL SERVICE BULLETIN Vista Roof - Rattle And/Or Squeak Noise While Driving With Roof Opening Panel Closed

19-2169

Ford 2015-2019 F-150

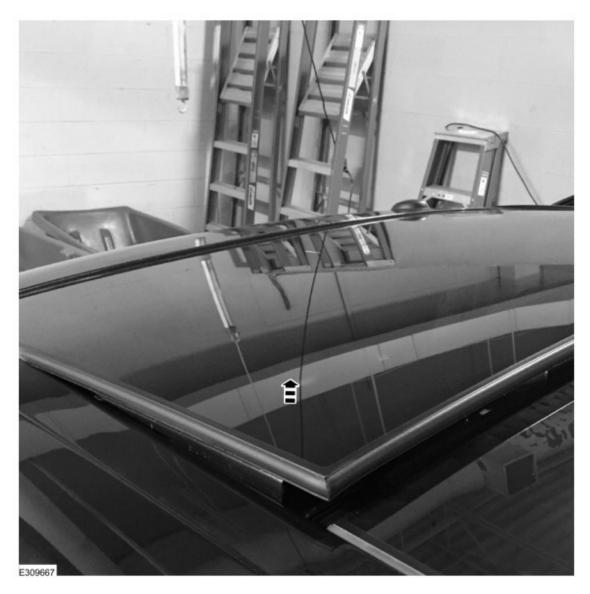
Figure 1

1. Position the glass panel to the vent position. (Figure 1)

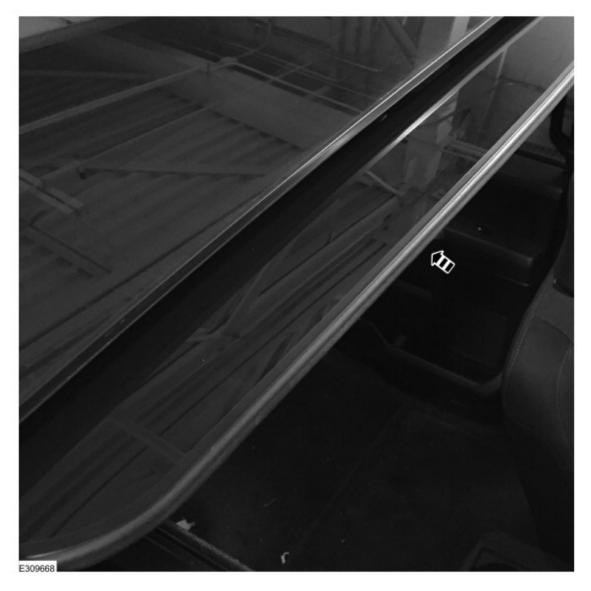
Figure 2

- 2. Clean the rear and side rubber seals of the movable glass panel with isopropyl alcohol or equivalent.
- 3. Clean the exposed sheet metal of the roof opening with isopropyl alcohol or equivalent.
- **4.** Position the glass panel to the fully open position. (Figure 2)

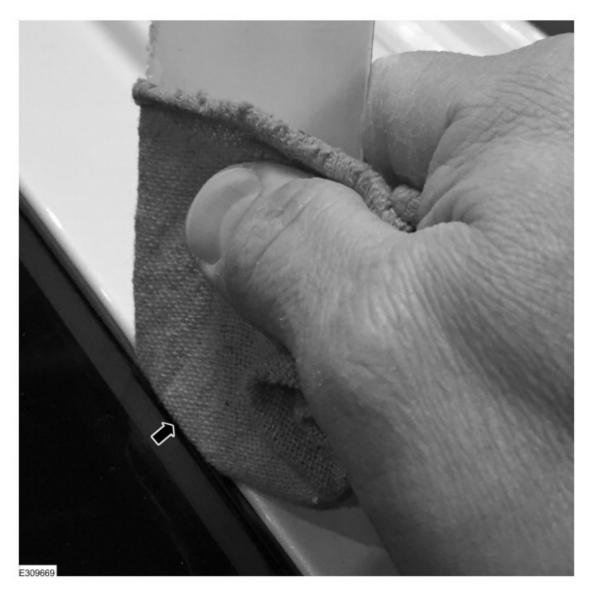
Figure 3

- **5.** Clean the remaining front rubber seal area of the movable glass panel with isopropyl alcohol or equivalent.
- 6. Clean the remaining exposed sheet metal of the roof opening with isopropyl alcohol or equivalent.
- **7.** Apply isopropyl alcohol or equivalent onto a clean cloth and insert it between the rear fixed glass panel seal and the roof opening sheet metal. (Figure 3)
 - (1). Folding the cloth over a flexible piece of plastic such as an old credit card or a thin piece of plexiglass will assist in the cleaning process.
 - (2). Slide the isopropyl alcohol soaked cloth around all sides of the fixed panel glass.

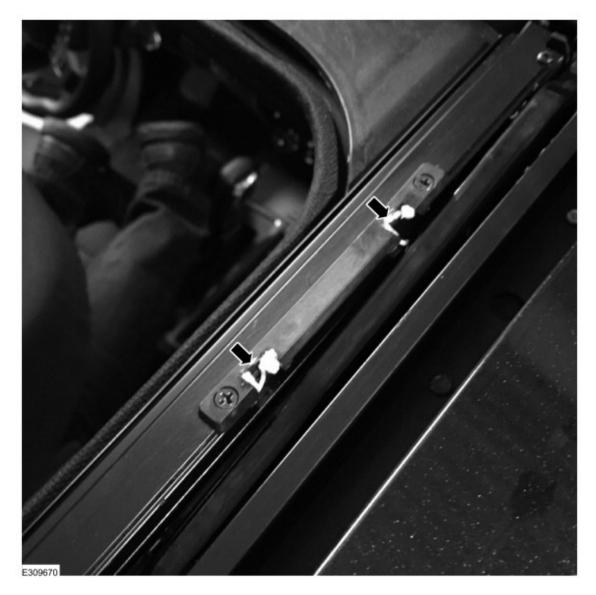
Figure 4

- **8.** Apply a light film of Krytox® grease to the entire sheet metal roof opening of the movable glass panel and the front edge of the movable glass seal.
- **9.** Hold the wind deflector down and apply Krytox® grease to both openings of the left and right front set plates. (Figure 4)
